## A STRUCTURAL ASSESSMENT STUDY ON THE SUSTAINABILITY OF SULTAN ISKANDAR BRIDGE KUALA KANGSAR PERAK MALAYSIA

The Sultan Iskandar Bridge in Kuala Kangsar in State of Perak, Malaysia was built around 1932. It was built for seven (7) spans, 284.01m length, crossing Perak River and bridging in the towns of Kuala Kangsar and Sungai Siput. Over the years, the Bridge has been carrying as increasing traffic loads on Route 1 Federal Trunk Road. Extensive corrosion of the steel trough supporting the Reinforced Concrete (RC) deck slab, triggered an emergency structural rehabilitation in 1986. Four (4) additional numbers of 16" x 7" x 45 lb/ft steel Universal Beam longitudinal stringers were added to reduce the RC deck slab transverse span. In July 2003, the Medium-Term Axle Load (MTAL) Policy was implemented in Malaysia through Weight Restriction Order (WRO) 2003. It allows an increase in legal load limits from 10-tonnes to 12-tonnes single axle load and a corresponding increase in Gross Vehicle Weight from 38-tonnes to 44-tonnes on the Bridge. Thus, necessitating the PWD to commission a full Structural Assessment Study to provide an engineering basis for management decision on the continue

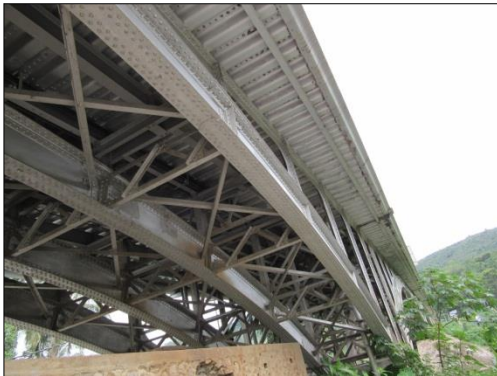
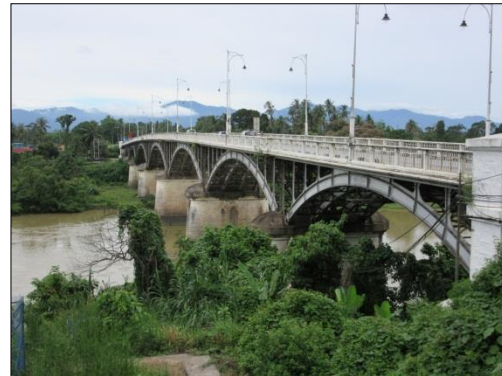
Figure 2: (a) Elevation View of Bridge; (b) View of Bridge Soffits.

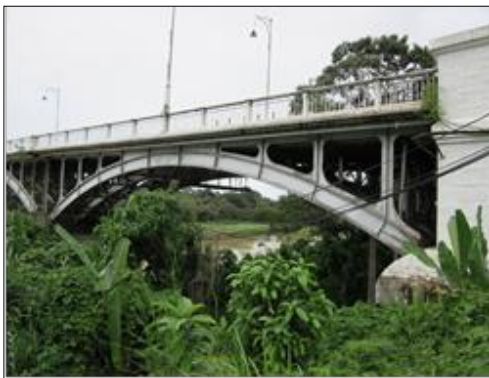
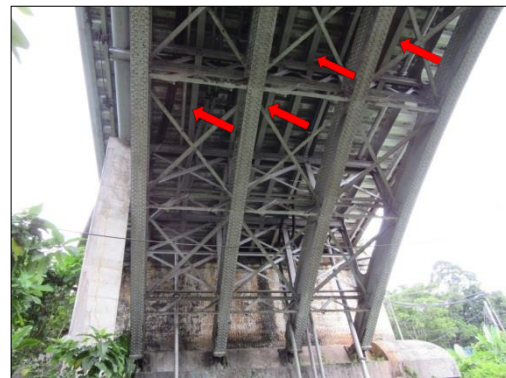
Figure 3: (a) Elevation View of End Span; (b) Added Universal Beam Longitudinal Stringers to Bridge deck soffits.

The Bridge on the Route 1 Federal Trunk Road has seen increasing traffic load over the years. No significant structural maintenance works have been carried out on the very well-constructed Bridge. Nevertheless, extensive corrosion of the transverse steel troughs supporting the Reinforced Concrete (R.C) bridge deck slab triggered an emergency structural rehabilitation in 1986. Due to the urgent needs to ensure the continued structural integrity of the bridge deck structural system, four (4) numbers 16" x 7" x 45 lb/ft. steel universal beam longitudinal stringers were added to augment the R.C deck slab transverse structural capacity (refer Figure 3):-

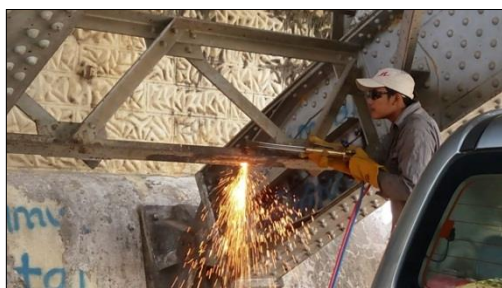
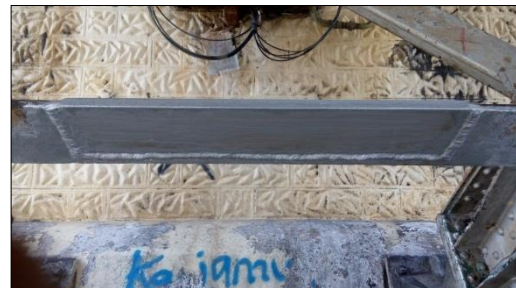
For the nominal material testing, it could be established that the bridge construction was carried out with good quality and durable concrete and steel material. Figure 4 shows the extraction of steel samples from the bridge.

**Figure 4: (a) Extraction of steel sample at Span 7; (b) the extracted steel section was immediately made good.**

- Concrete compressive strength of: -
  - Bridge Deck > 40 N/mm<sup>2</sup>
  - Bridge Piers > 30 N/mm<sup>2</sup> (Adoption of f<sub>cu</sub> = 25 N/mm<sup>2</sup> OK)
- Steel Yield Strength > 226 N/mm<sup>2</sup> (Adoption of f<sub>y</sub> = 220 N/mm<sup>2</sup>)
- Concrete Carbonation Depth < 1 mm
- Chloride content in cement < 0.07% by weight of concrete
- Plate thickness loss about 4.2%

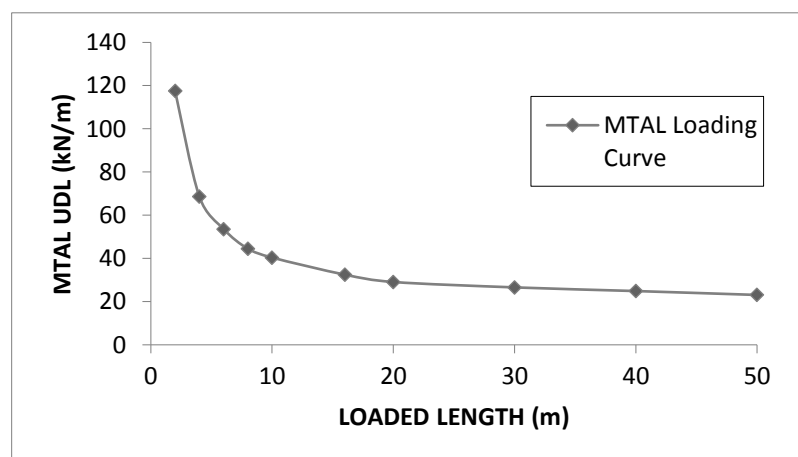
**Figure 5: MTAL Uniformly Distributed Load**

For ease of reference, the regime of various live loadings for MTAL traffic loadings are presented on Table 1 and Figure 5.
